Central Valley Regional Water Quality Control Board

REPORT OF 27 APRIL 2023 INSPECTION, HEATHER GLEN ESTATES MOBILE HOME PARK WASTEWATER TREATMENT FACILITY, PLACER COUNTY

INSPECTION REPORT

INSPECTION DATE: 27 April 2023

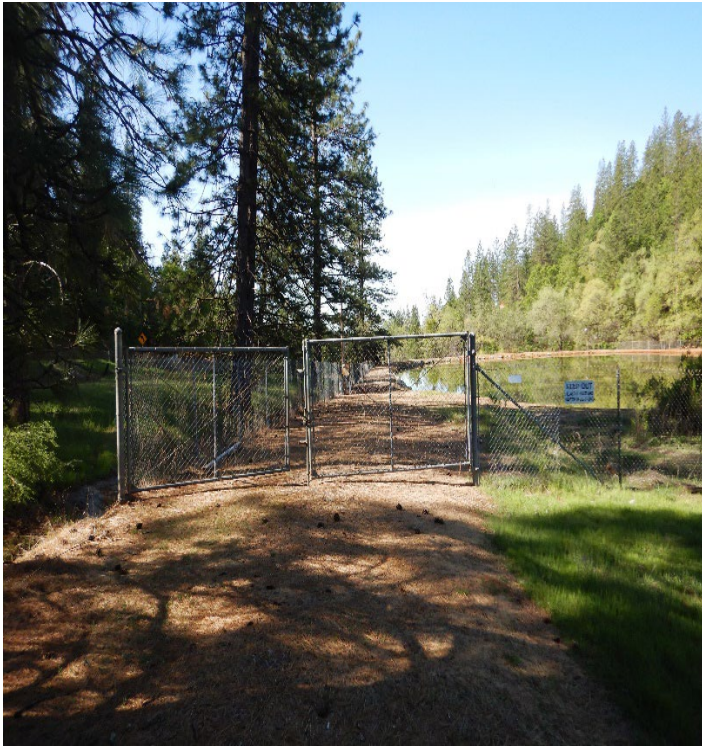
1. The percolation/evaporation pond was surrounded by a fence and a locked gate (Photo 1).
2. Board staff observed an influent flow meter at the facility. The meter was last calibrated on 12 October 2022 and is calibrated annually.
3. The freeboard in the percolation/evaporation pond was three feet (Photos 2 through 4). The aeration system for the pond was not on at the time of the inspection.
4. The land application area above the wastewater pond was not being used at the time of the inspection (Photo 5). Wastewater that is applied to the land application area is via spray irrigation methods through small holes (approximately quarter inch in diameter) in the 2-inch PVC piping that are spaced approximately every 6 inches (Photo 6).
5. The tailwater collection ditch associated with the land application area was dry at the time of the inspection (Photos 7 and 8).

Photo No. 1: Security fence with locking gate surrounding the wastewater pond.

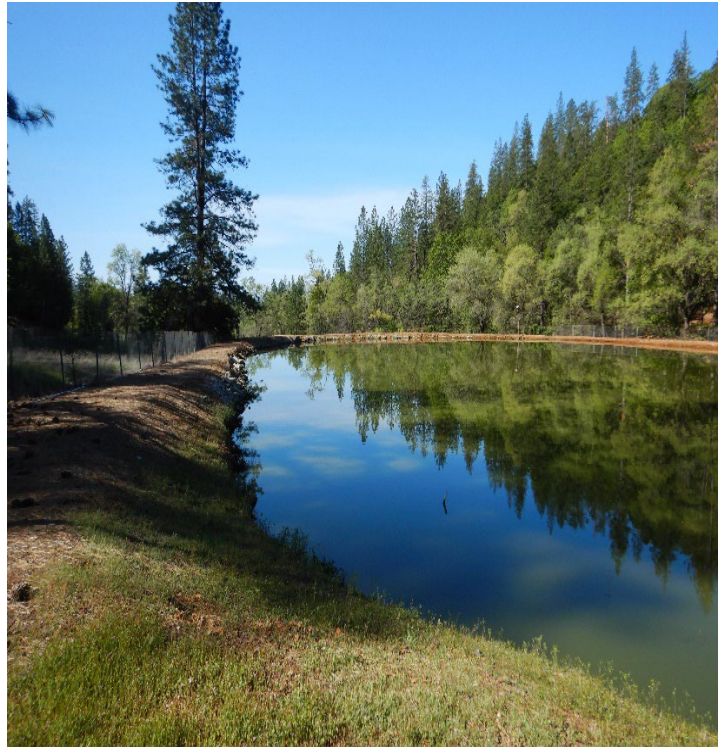
Photo No. 2: Looking south at the wastewater pond.

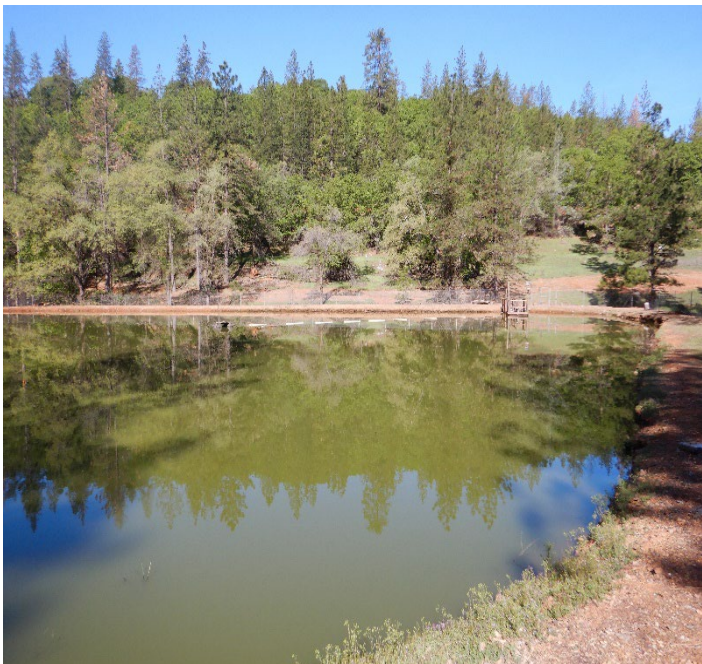
Photo No. 3: Looking west at the wastewater pond.

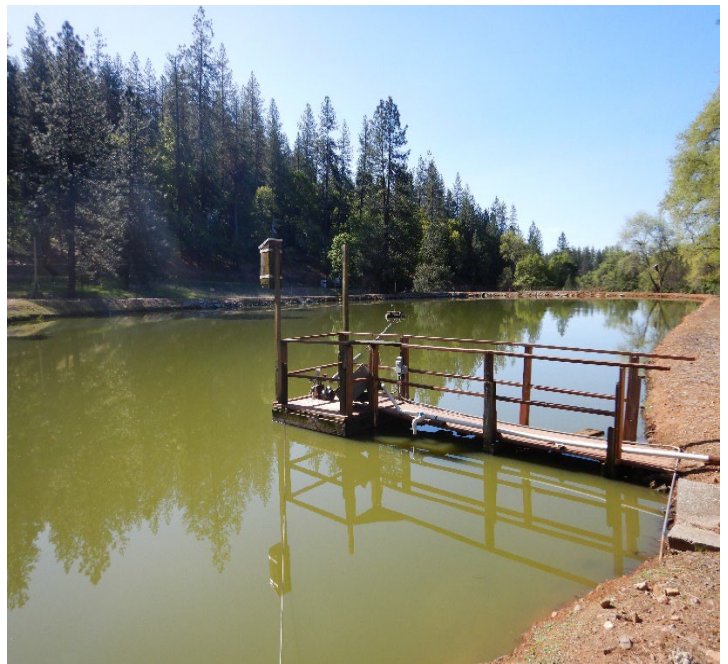
Photo No. 4: Wooden structure that supports pump for the spray aeration system and piping that leads to the land application area.

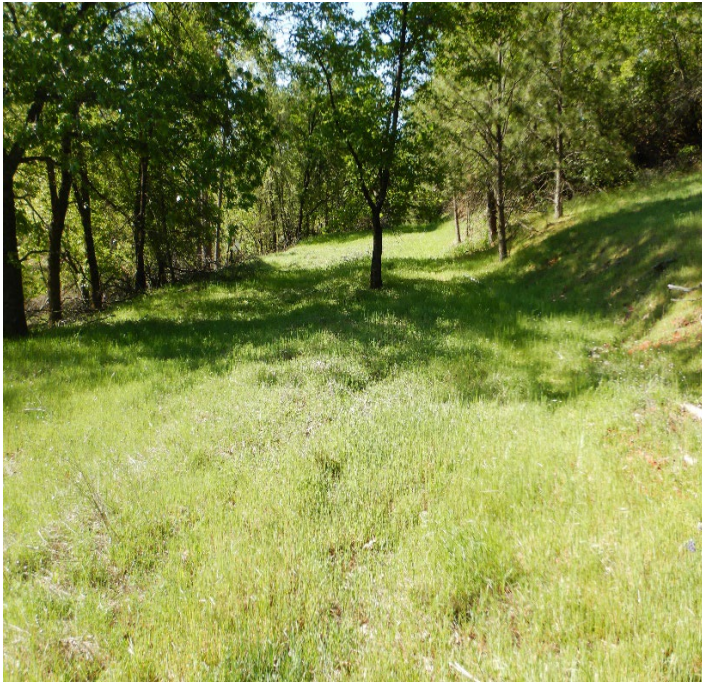
Photo No. 5: Looking south at the land application area.

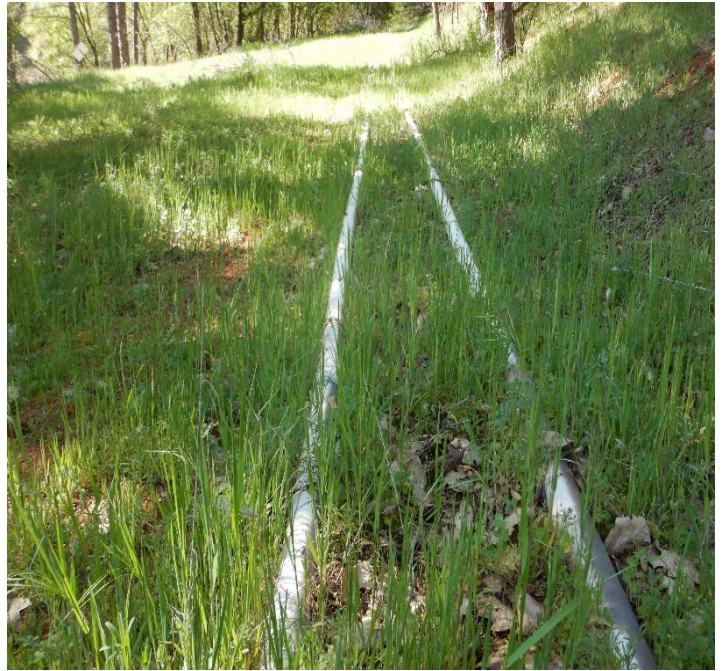
Photo No. 6: Looking south at the land application area and the PVC piping used for drip irrigation.

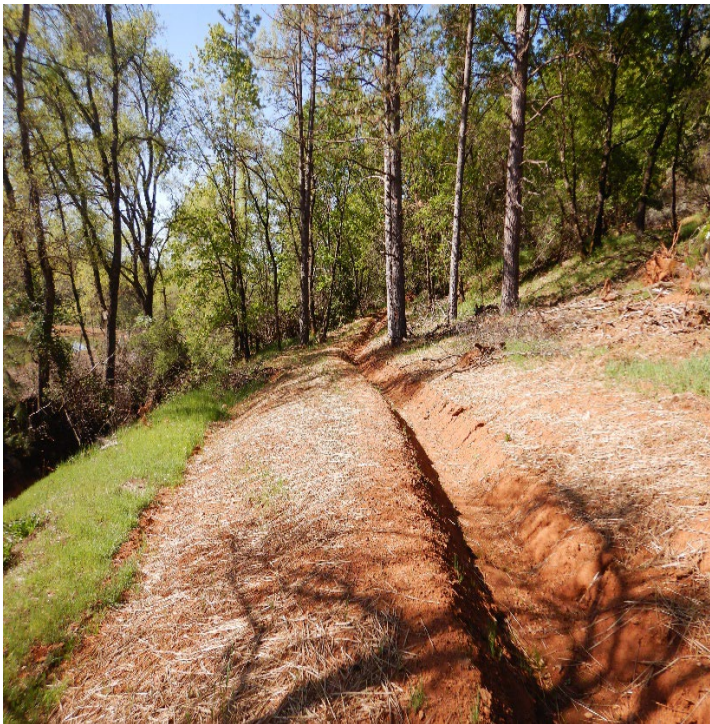
Photo No. 7: Tailwater collection ditch associated with the land application area.

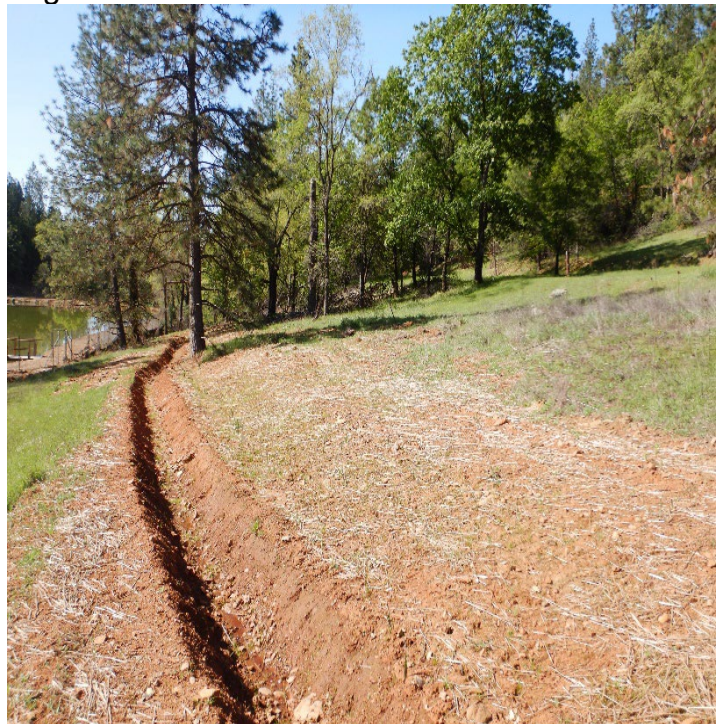
Photo No. 8: Tailwater collection ditch associated with the land application area.

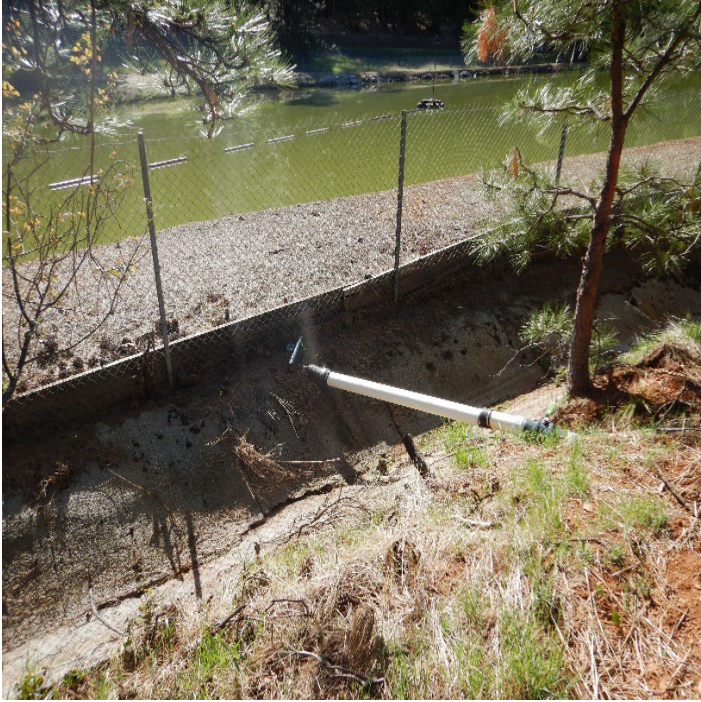
Photo No. 9: Piping from tailwater collection ditch to the wastewater pond.
